## HOTEL COOLING TOWER & HEAT EXCHANGER CLEANING

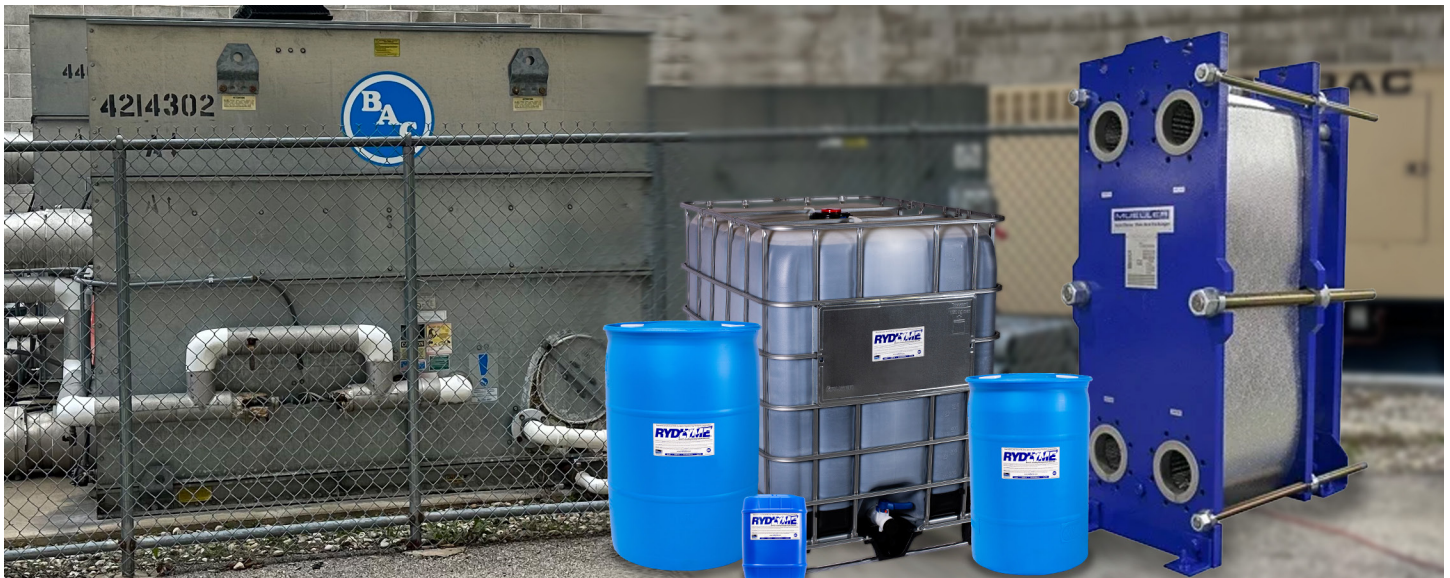
A beach side hotel was experiencing scale issues within their cooling tower and heat exchanger. After inspection, the main culprit was water scale that had accumulated within the plate & frame exchanger as well as the cooling tower fill. The cooling tower water had only 6° ΔT, the heat exchanger was achieving a 13° ΔT.

Water scale was creating cooling issues in a cooling tower & heat exchanger at a beach side hotel.

Circulating 100 gallons of **RYDLYME** through the system for 8 hours solved their cooling problem. After a water flush, the cooling tower & heat exchanger were returned to service. The cooling tower now had a 10° ΔT which was a 66% increase and the heat exchanger had a 28° ΔT which was a 115% increase! The hotel personnel were amazed at the difference! With the dramatic improvement in efficiency, the hotel was convinced to have **RYDLYME** as a preventative maintenance program for future cleanings! The cleaning tech walked in to a round of applause now that the AC was fully operational for the summer season!

Circulating 100 gallons of **RYDLYME** was circulated for 8 hours with a water flush after the **RYDLYME** cleaning was completed.

After the **RYDLYME** cleaning, the ΔT in the cooling tower increased 66% and the ΔT in the heat exchanger increased 115%!
