PAPERBOARD PRESS PLATE CLEANING

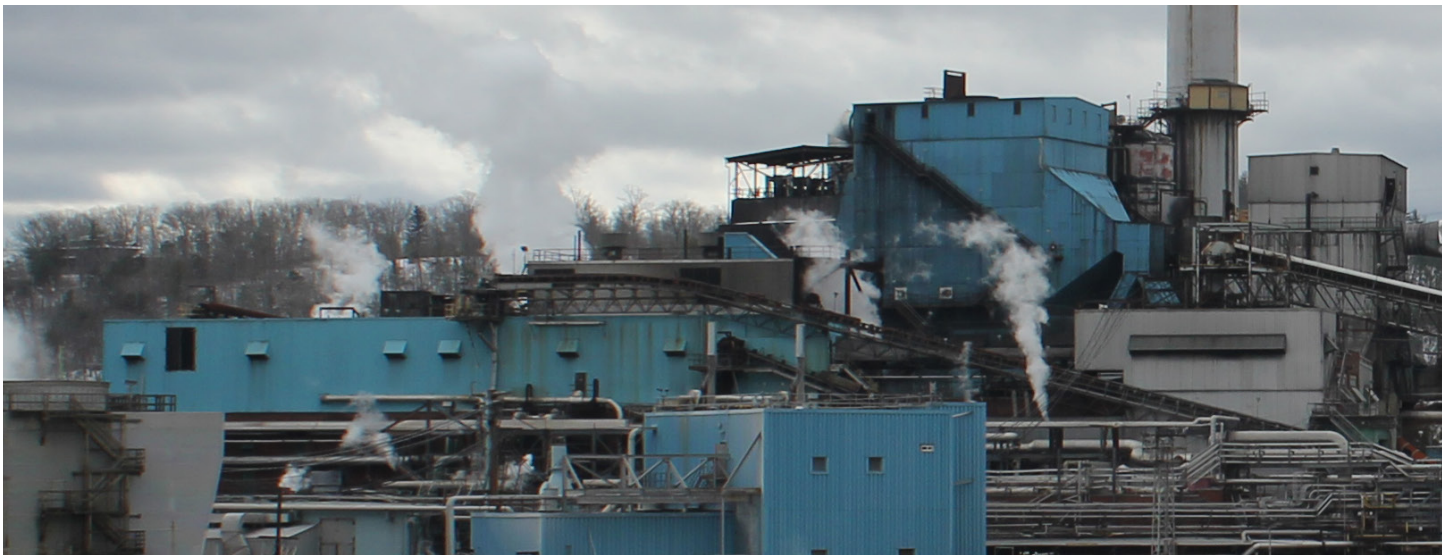
A paper mill was experiencing heating issues with their 36 paperboard press plates. Stacks of paper are inserted between two plates that press together creating boards for the exterior of homes. Steam is injected into the plates to reach the required 450°F. The mill was unable to reach this required temperature due to mineral deposit accumulation resulting in inferior products.

A 55 gallon drum of **RYDLYME** was circulated through each plate for 6-8 hours, depending on the severity of the scale inside. Upon circulation completion, each plate was inspected with a fiberscope. The inspector saw that **RYDLYME** brought these plates back down to bare metal and the correct temperature was obtainable yet again! The mill is now cleaning these plates on a 3 month rotation!

A 55 gallon drum of **RYDLYME** was circulated through each of the 36 press plates for 6-8 hours depending on scale severity (1,980 gallons total).

The inspector was extremely happy to see the plates were returned to bare metal! The plates were now able to reach the correct temperature and the plant cleans them on a 3 month rotation!
